## MEMS reliability in a vibration environment

Danelle M. Tanner, Jeremy A. Walraven, Karen S. Helgesen, Lloyd W. Irwin,  
Danny L. Gregory, John R. Stake, and Norman F. Smith

Sandia National Laboratories, P.O. Box 5800, MS 1081, Albuquerque, NM 87185-1081  
<http://www.mdl.sandia.gov/Micromachine>  
email: [tannerdm@sandia.gov](mailto:tannerdm@sandia.gov)

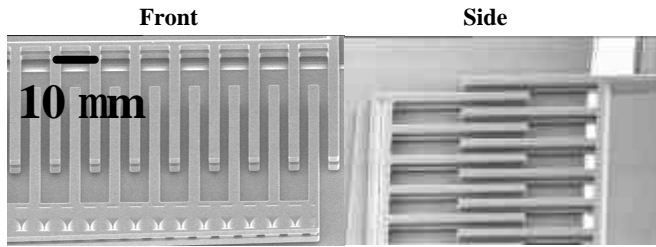
permit unobstructed viewing of the bottom level of polysilicon comb fingers. Analysis could be conducted with the shuttle intact, but any defects that may occur on the bottom level of the comb fingers from the side would be obstructed from the comb fingers as illustrated in figure 13.

**Figure 13.** Front and side views of a 40° tilted micromachine comb drive actuator. Note the tips of the comb fingers can be viewed, but the mobile shuttle obstructs characterization from the side of the stationary comb fingers.

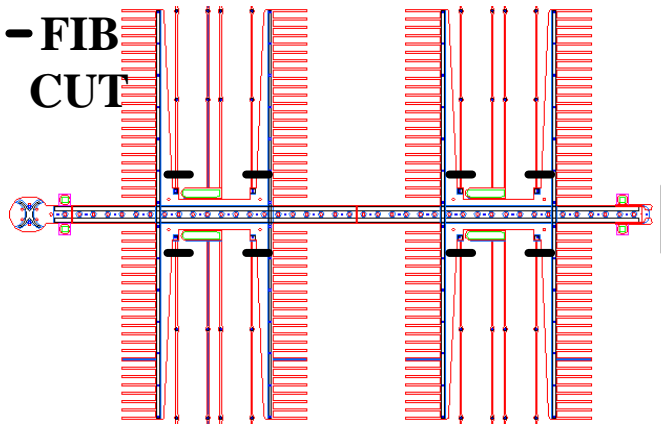
The FIB cuts involved severing nine polysilicon lines as indicated by the dark lines of Figure 14. Here, nine FIB cuts were made along thin regions of polysilicon located at the front and back anchors (four FIB cuts per anchor). The ninth FIB cut is performed at the flexure located just before the linkage arm connecting the shuttle to the gear. The released shuttle was then removed from the micro-engine utilizing a probe tip with a sticky adhesive at the tip of the probe. This method removed the shuttle without inducing damage along the stationary comb fingers.

**Figure 14.** AutoCad rendered image of a Sandia fabricated comb drive actuator. Each thick line indicates a region where a FIB cut has been performed (4 for each spring anchor, and one for the flex arm).
